BB Residential Inspections

Property Inspection Report

1234 xxxx Street, Baltimore, Maryland xxxxx

Date of Inspection: 10/9/2019 Time: 6:00 PM

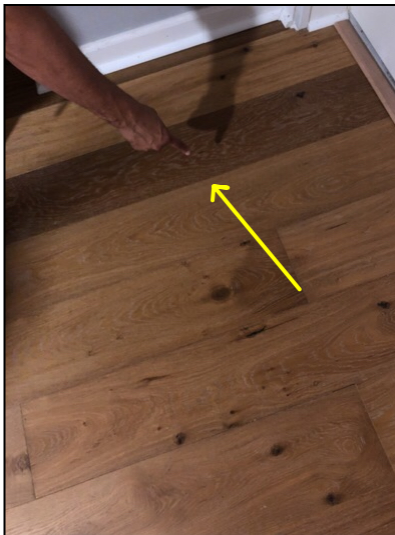
- The living room flooring has a weak spongy spot right by the front door. Recommend repair by a licensed contractor.

Weak spot in flooring

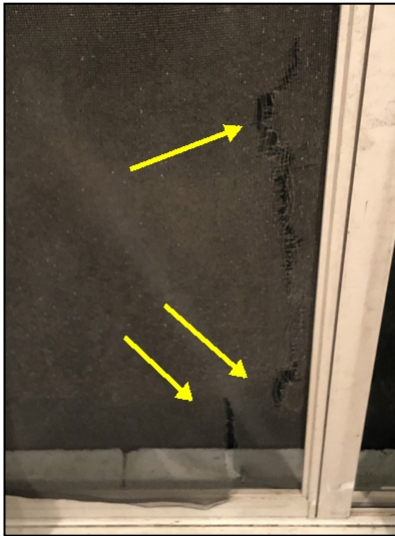
- Sliding screen door is torn and is difficult to operate.

Damaged screen door.

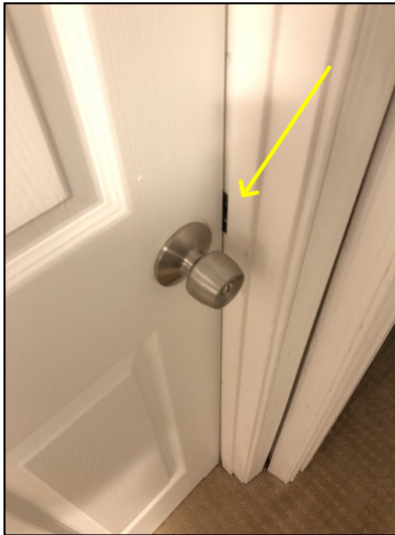
- **Outside back bedroom door does not latch shut. Recommend striker plate adjustment.**

Door does not latch shut

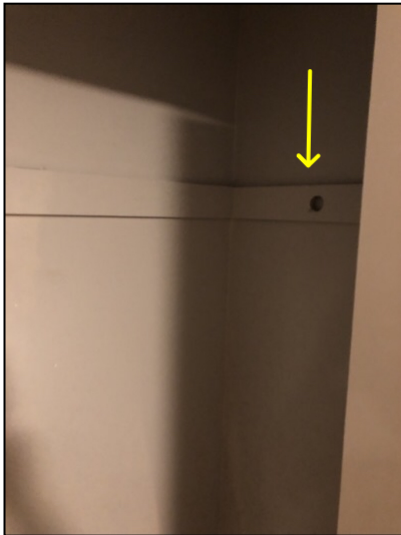
No rod or shelf in all bedroom closets

- **All bedroom closets do not have rods or shelves mounted. Recommend installation.**
- **Recommend holes in closet wall be patched and painted.**

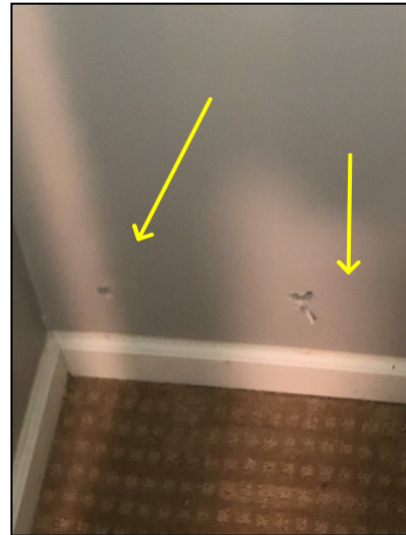
Holes in closet wall (front bedroom0

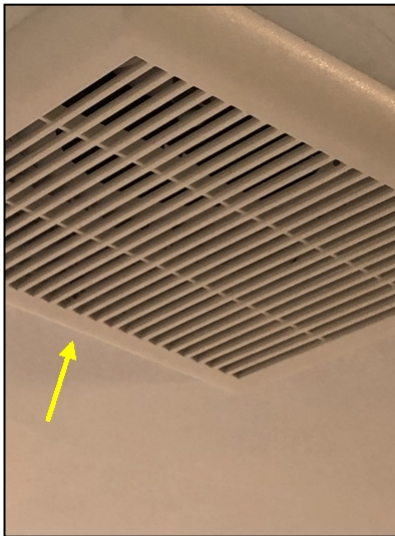
- The second floor bathroom has a window and no bath fan. Although this is generally an acceptable practice, a bath fan is recommended to prevent moisture accumulation when the weather makes opening the window uncomfortable.
- **The bathroom in the basement has an inoperative bath fan. The bathroom does not have a window that opens so it must have an operational bath fan. Recommend servicing by a licensed technician.**

Inoperative fan in basement bath

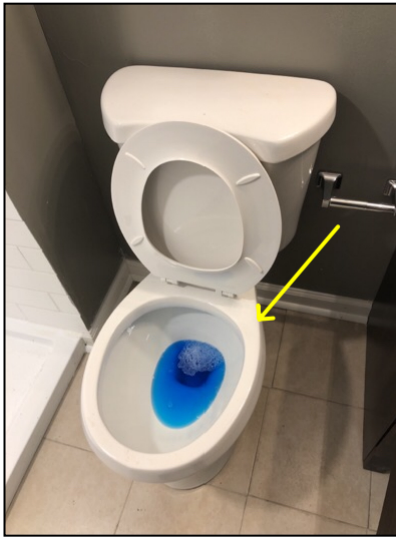
- **The toilet in the basement bathroom is very loosely mounted. Recommend servicing by a licensed plumber.**

Loosely mounted toilet

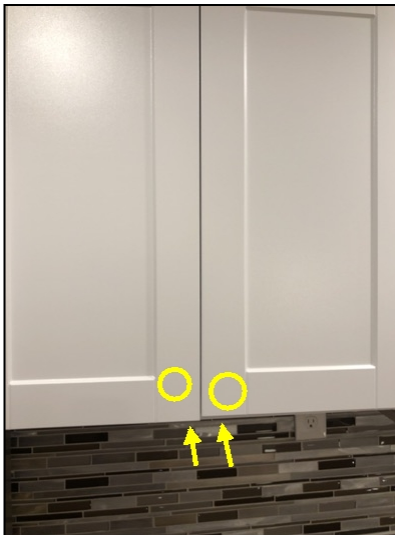
- The cabinet doors are off-line and have no knobs on the doors or drawers. Recommend installing knobs and lining up doors appropriately.

Doors out of line and missing knobs.

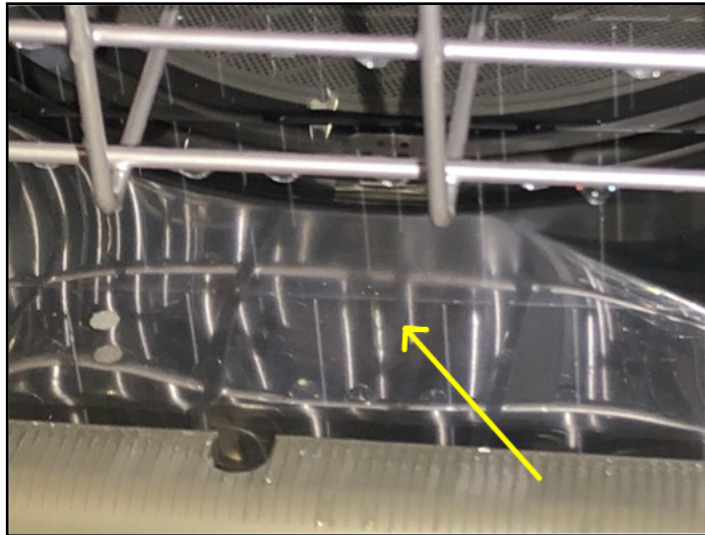
- The dishwasher did not operate when tested, consult with the seller about servicing the unit. The dishwasher ran a cycle but would not drain.

The dishwasher would not drain

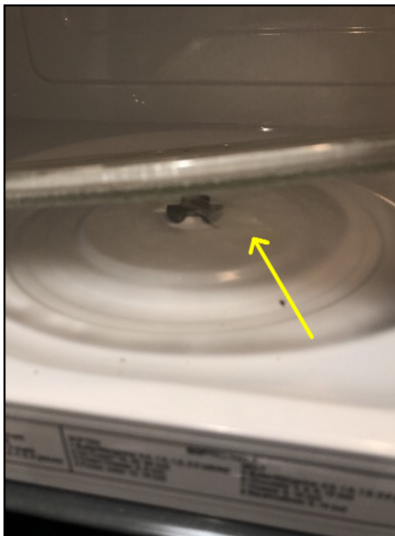
- Microwave missing turntable wheels

Microwave turntable

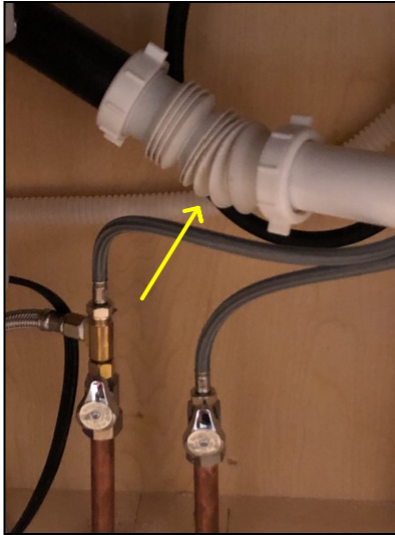
- Flex drain observed, these are subject to frequent clogging.

Flex drain under kitchen sink

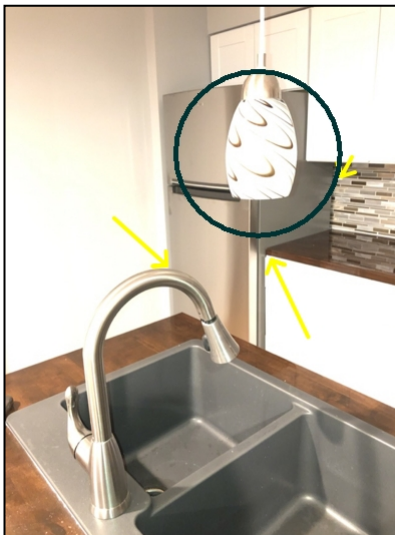
- The counter lamps in the kitchen are too close to the sink. Recommend moving the lamp higher for safety.

Counter lamp in kitchen

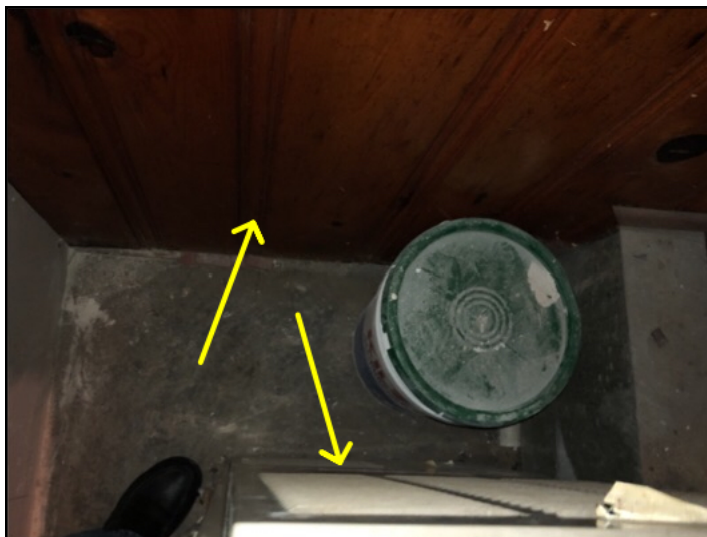
- Although the heater base appears in good condition the front access panels of the heater are directly next to a wall making it very difficult to gain access. Recommend the heater assembly be moved so that access is possible.

Are insufficient space between heater access and wall

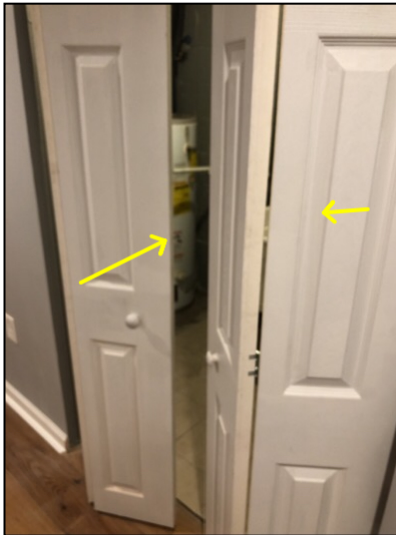
- The water heater, air handler and laundry are located in a small room in the basement. This room does not have sufficient **combustion air**. Recommend that the doors to the laundry room to be replaced with louver doors to provide more combustion air.

Heater closet enclosure doors

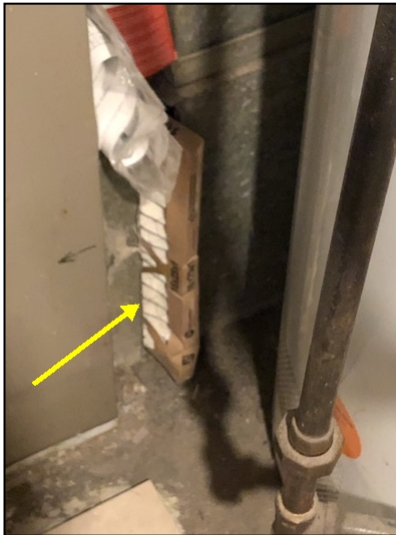
- There is no cover for the filter housing. Recommend installing a cover to prevent combustion air from entering the furnace.

Filter uncovered.

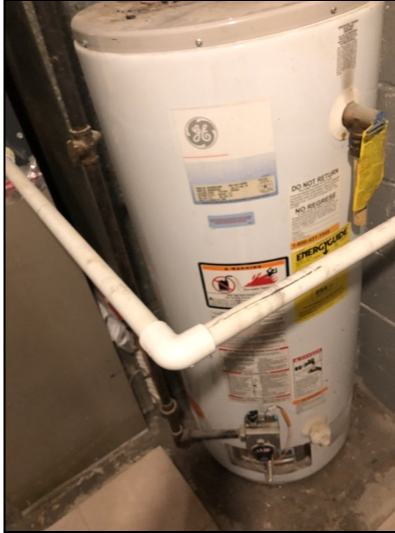
- The water heater is a 2008 model that was inoperative during testing. Recommend replacement.

Inoperative water heater

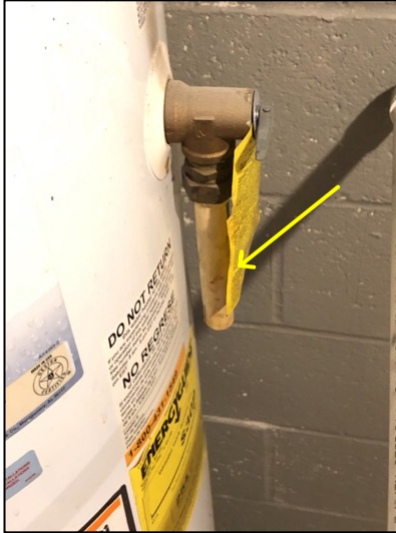
- The discharge tube discharges above six inches from slab, this should be lowered due to the possibility of scalding should a discharge situation happen.

Overflow pipe too short

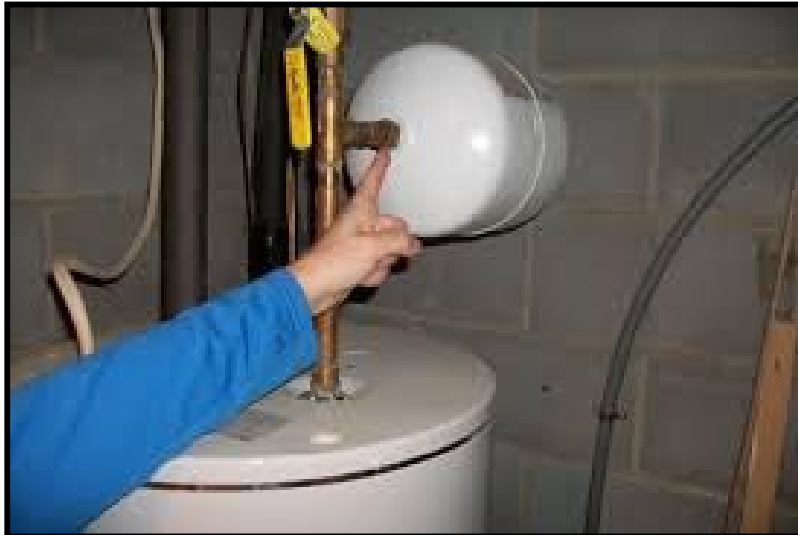
- Recommend adding an **expansion tank**. The expansion tank serves as a backup system to prevent overworking your plumbing. The excess water volume, instead of causing too much pressure on the plumbing, rushes into the expansion tank and lowers the pressure in the water heater to safer levels.

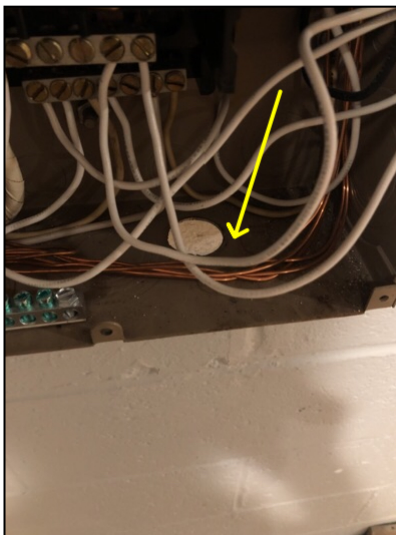
- There is a large uncovered hole in the bottom of the sub panel. Recommend this hole be covered to prevent pest entry or electrical shock.

Hole in the bottom of sub panel

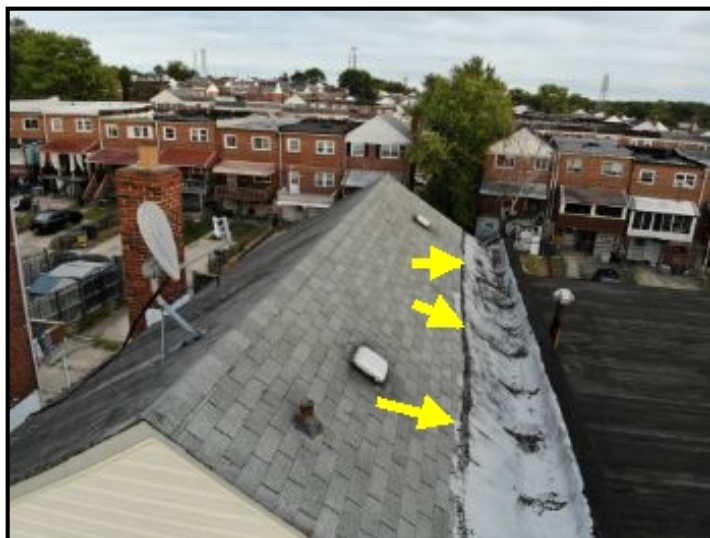
Roof Roof Condition

- The material used as roof covering on the bottom edge of the roof slope is inappropriate for this type of roof and will develop leaks over time. Recommend roof covering replacement.

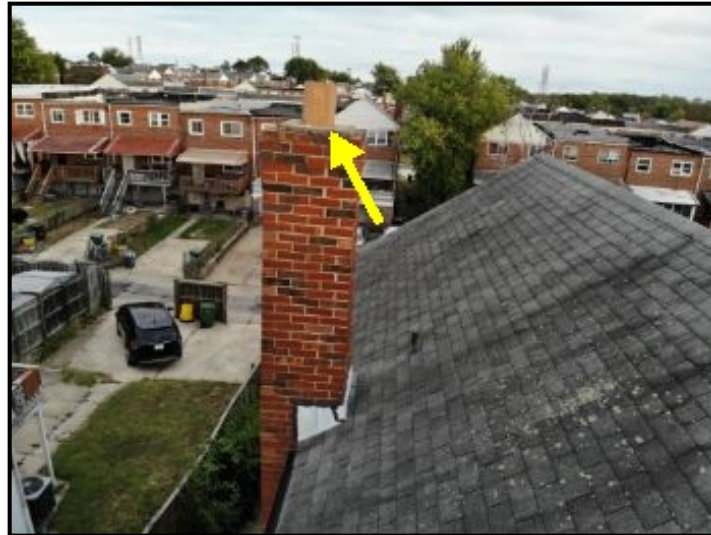
Roof Chimney

- The chimney crown is cracked and undersized. Recommend crown replacement by a licensed chimney sweep.

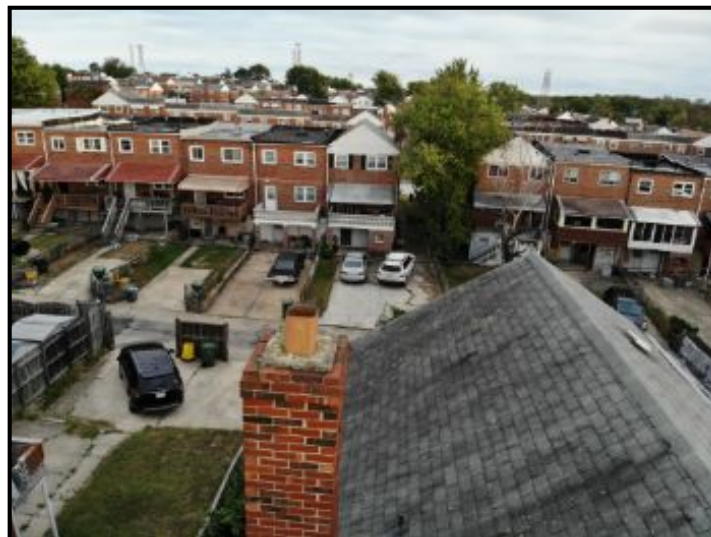
Roof Spark Arrestor

- Spark arrestor and rain cap suggested.

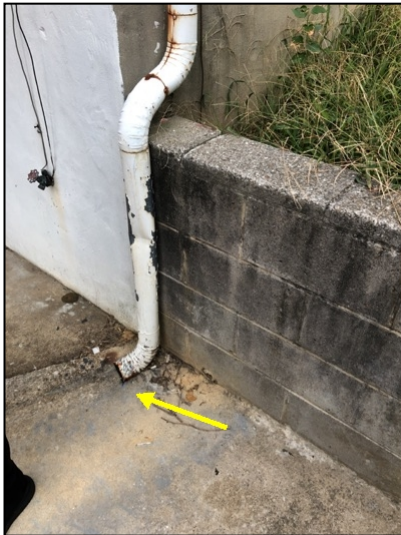
- Extensions / Splash blocks missing or insufficient: Install to divert water away from the foundation.

Downspout end crushed

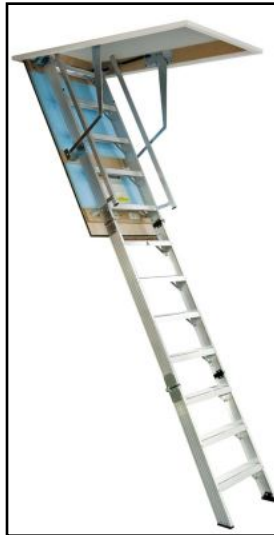
- ****Location of access****
- Scuttle Hole located in:
 - Bedroom Closet.
- **IMPROVE:** The attic access is not insulated. Expect some energy loss through convection. Recommend insulating attic access hatch cover@@pull down ladder@@ with a batt of fiberglass insulation to reduce energy expenses. See diagram for detail.
- **IMPROVE:** Recommend professional installation of a Pull Down Ladder for ease of attic access.

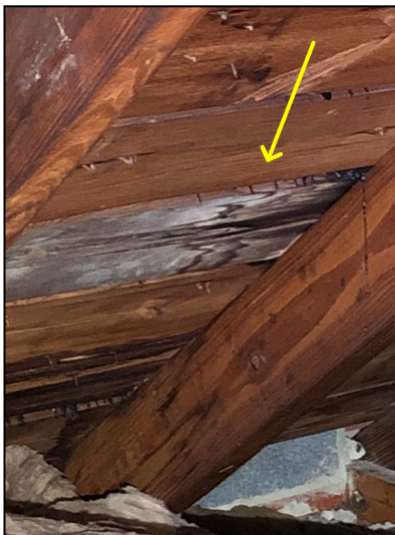
- **Evidence of past or present leaks, dry at time of the inspection. Monitor for leaks &/or have roofing contractor evaluate.**

Area of previous leaking, dry during inspection

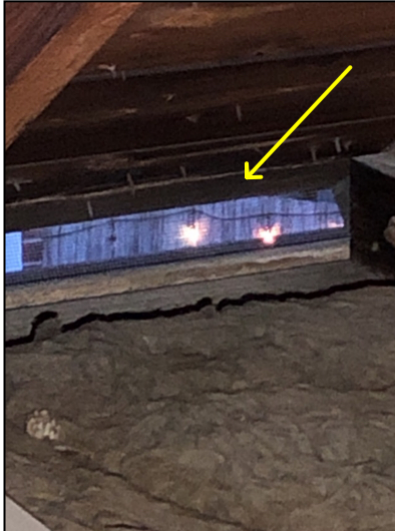
- Under eave soffit inlet vents noted.
- One side of the house had soffit vents installed with screening, however there was no ridge vent or gable vents for the air to exit. Recommend adding either gable vents or ridge venting to improve the ventilation in the attic.

Soffit vents with screening installed

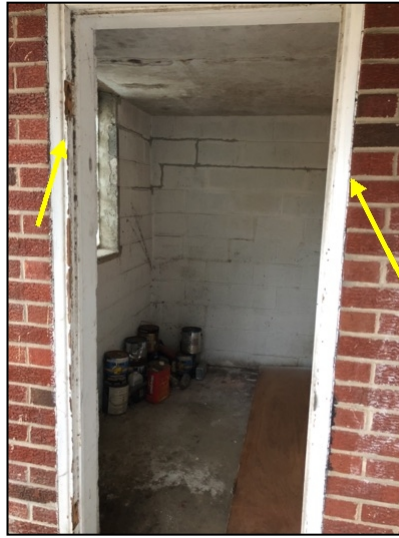
- The door to the storage area under the rear deck is dismantled. Recommend installing the door to create a usable secure storage area.

Door to storage area under deck dismantled

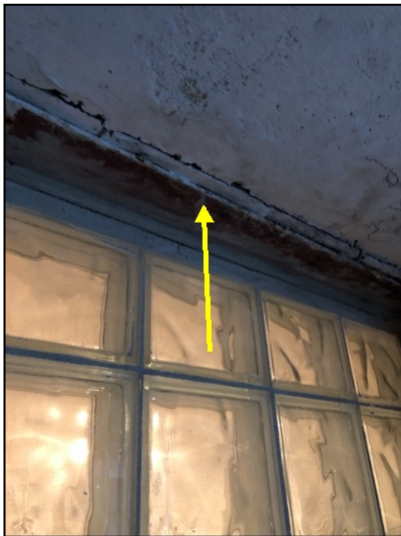
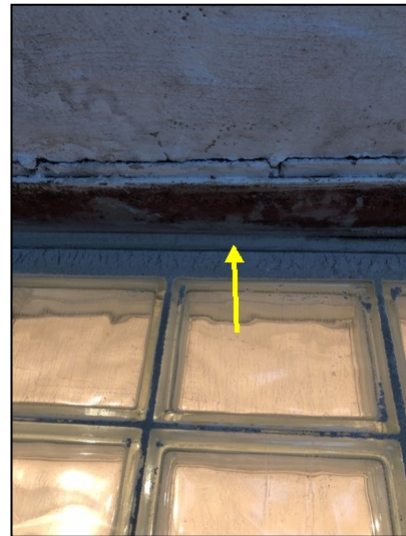
- The glassblock windows in the deck storage area need caulking to prevent moisture and pest entry.

Window in storage area under deck needs caulk

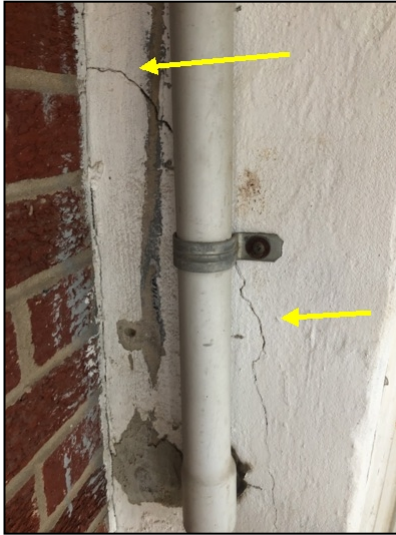
Cracked parging

- Recommend filling and repainting all cracks in the exterior parging.

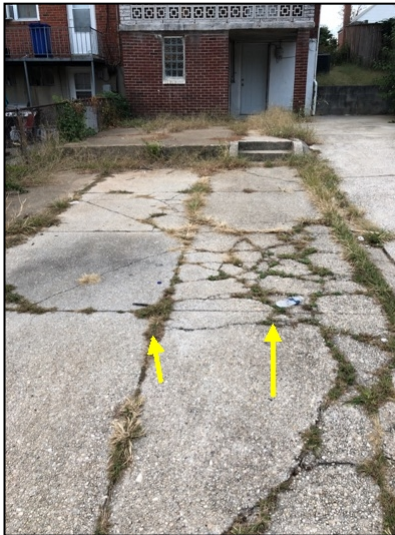
Cracked, plant filled driveway

- Recommend removing all plants from cracks in driveway and patching the driveway to prevent further deterioration.

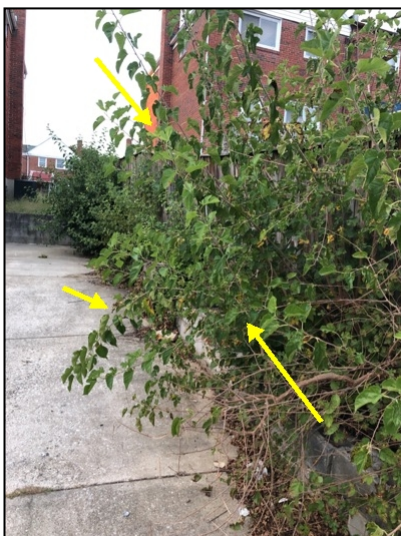
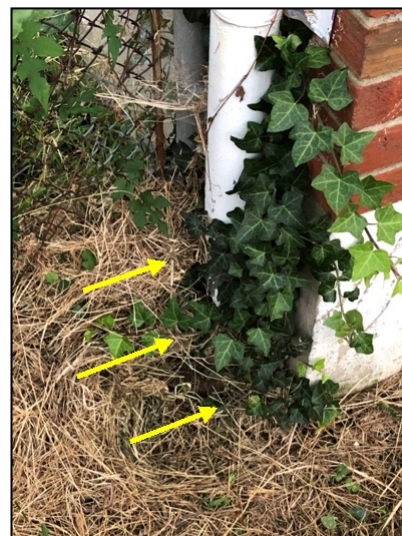
- Plants in close contact to siding, fixtures and fences causes rapid deterioration and pest entry into the structure. Recommend removal to prevent further deterioration.

Heavy vegetation growth over driveway

Weeds and vines around drain

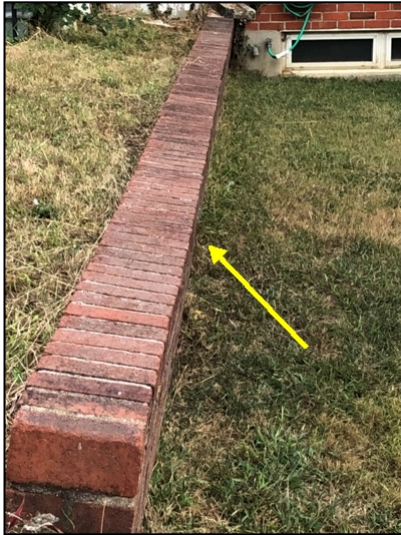
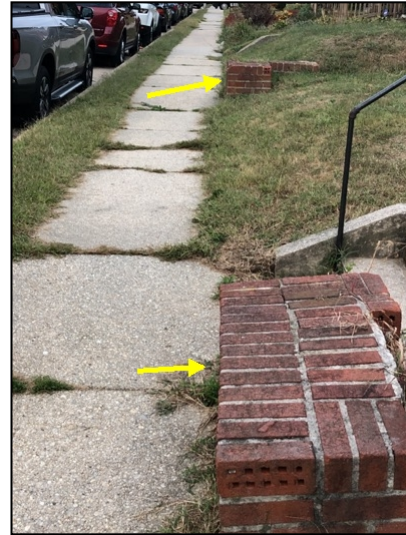
- The retaining wall in the front yard is leaning due to incorrect installation. Recommend removal and replacement with appropriate material.

Retaining wall leaning

Decorative wall leaning

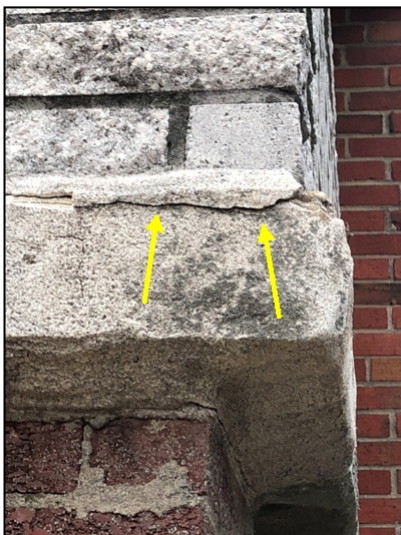
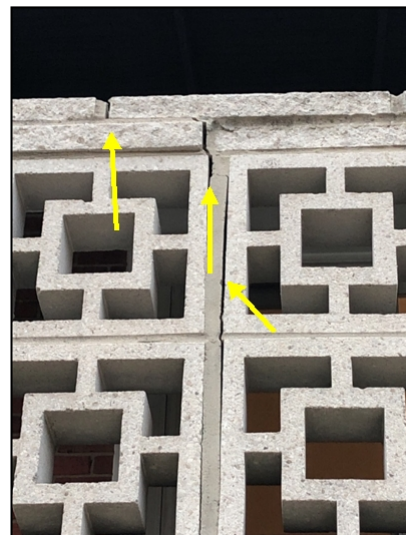
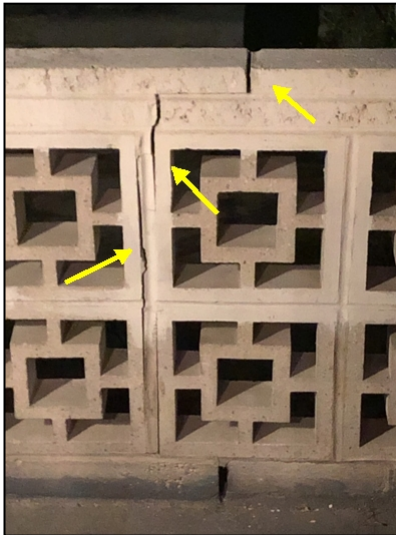
- There are cracks in the safety wall and support of the deck structure that should be evaluated for repair by a licensed contractor.

Cracking deck platform

Cracking safety wall

Cracked safety wall

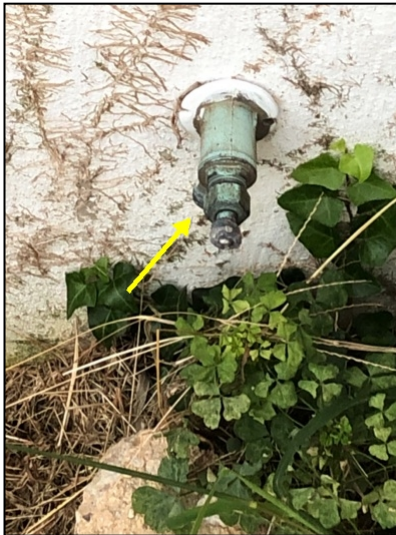
Front exterior faucet

- **The front faucet is missing the handle. Recommend replacement.**

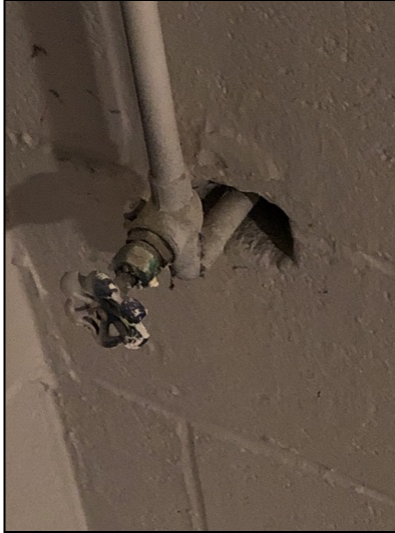
- The area of the basement wall where the water supply line for the spigot exit needs to be filled.

Large gap by rear exterior faucet

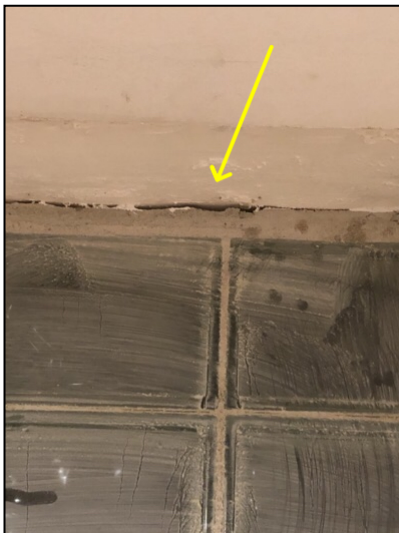
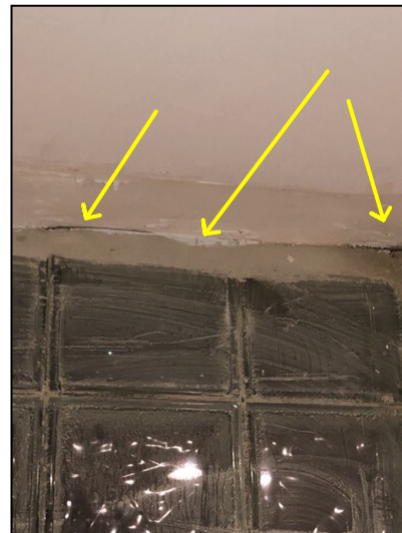
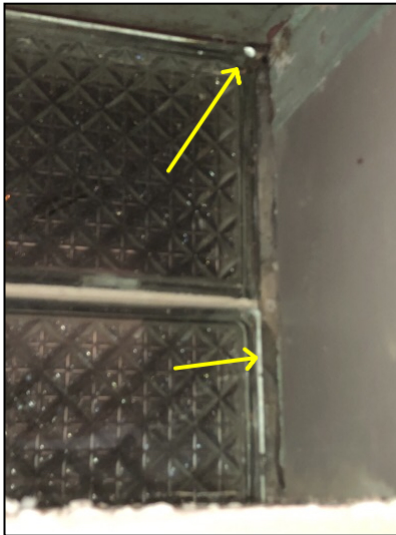
- The top of the glass block windows in the basement need to be caulked to prevent outside air and pest from entering the basement.
- The glass block window in the basement bathroom needs caulk around the entire window to prevent past entry

Glass block window in basement needs caulk

Basement bathroom glass block window needs caulk.

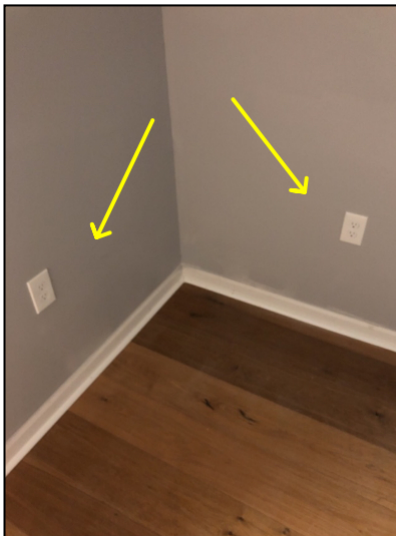
- **Open ground - receptacle in basement wall. Recommend repair by a licensed electrician.**

Open grounded outlets

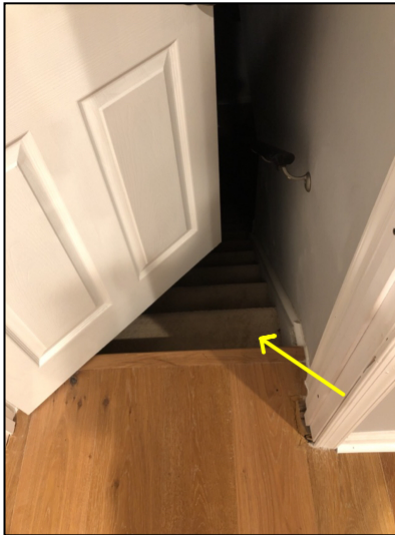
- The door to the basement opens over the stairs. Recommend remounting the door to open over the floor of the kitchen. This is a safety requirement.

Basement door opens over stairs

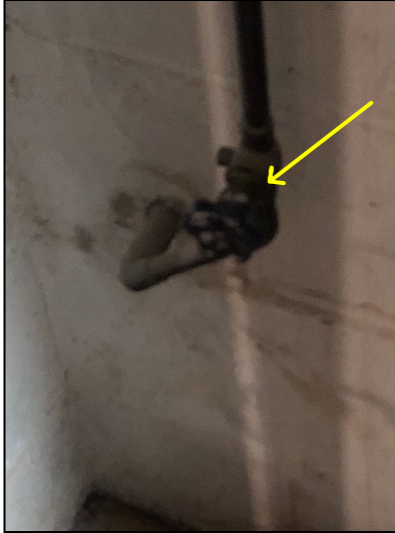
- Leak at main water shut off. Recommend servicing by a licensed plumber.

Leak at water main
